**OPERATIONAL DEMONSTRATION AND EVALUATION OF THE
FLEXIBLE WING PRECISION DROP GLIDER
IN THAILAND, MARCH-JULY 1963,**

MRDC-T 63-017

by
Author: ~~Lt. Col.~~ William R. Quinn
United States Marine Corps

Joint Thai-U.S. Military Research and Development Center
Thailand

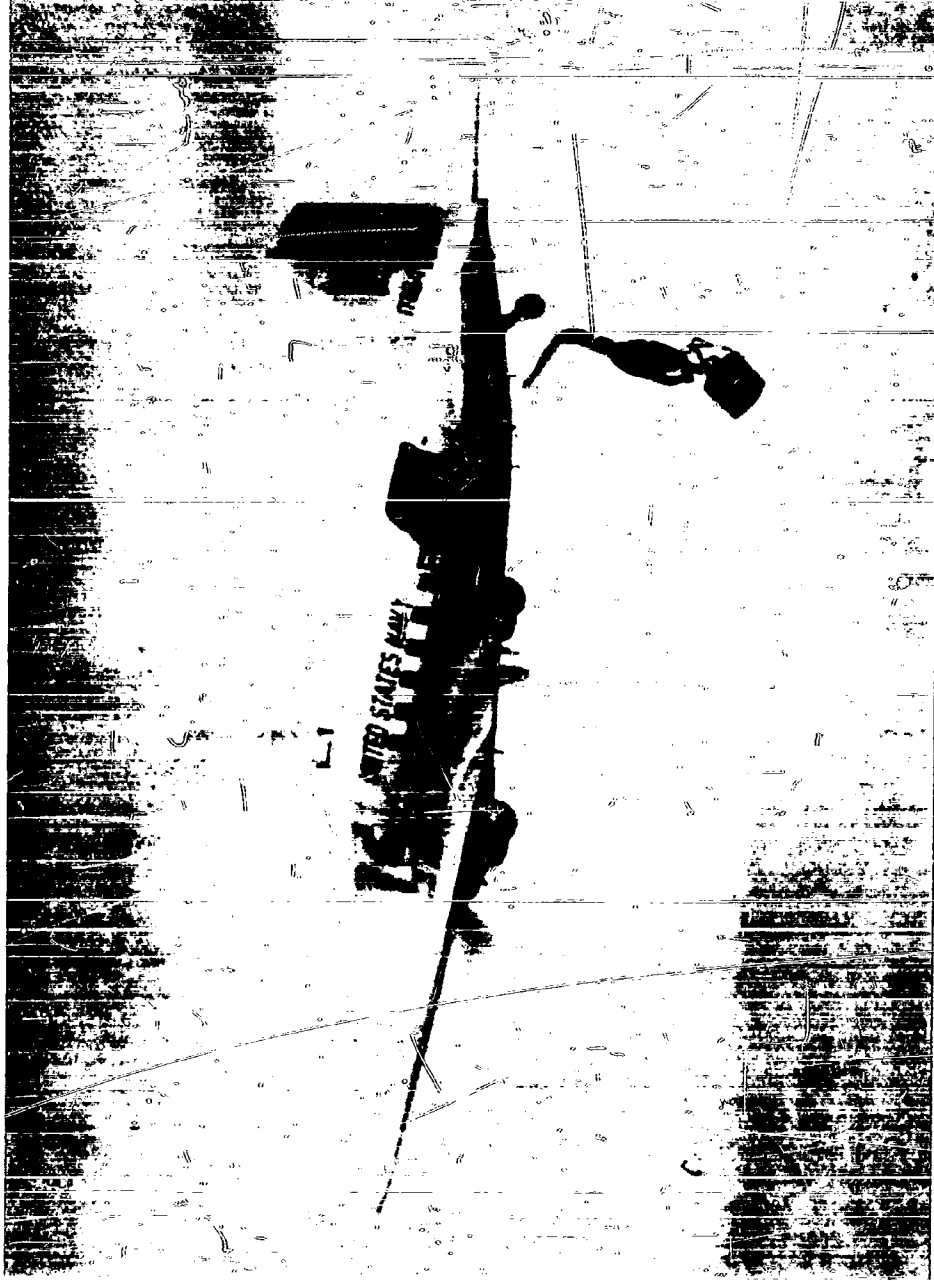
Precision Drop Clicker drop from U.S. Navy C-47 over Hua Hin, Thailand. Note riser already free allowing loose line to wrap around metal riser fittings. This particular drop resulted in riser entanglement.

13. Early in the program, it became apparent that the main cause of malfunction in the PDG was line entanglement. Entanglement is caused by the line coming free during the parachute mode and wrapping around the wing, causing distortion of the wing when it deploys into the glider configuration. The lines causing the problem are those lines not used in the parachute mode. They are stowed on the wing gussets under restraining bands until needed for the glider configuration. Twisting and flexing of the wing during deployment free this excess line prematurely, allowing it to flail around in the airstream and wrap around the wing. The risers were also coming free prematurely and loose line twisting around the heavy metal riser fittings caused additional entanglement problems. A field fix was attempted to restrain the risers but it was only partially successful.

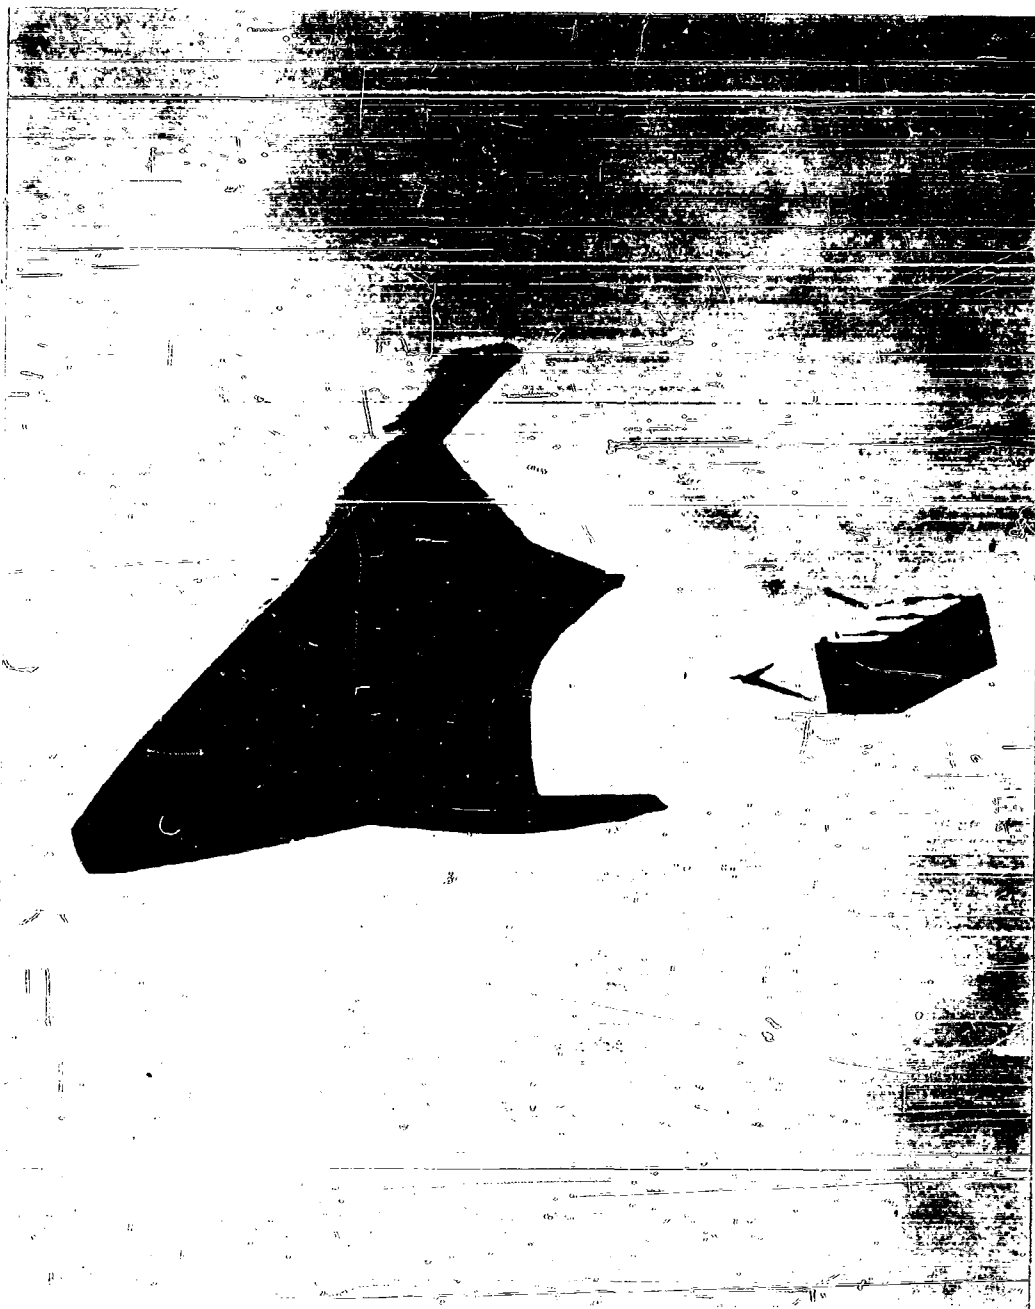
This picture shows a Flexwing with entangled riser lines. This had the effect of reefing the forward lines, causing a slight distortion of the glider wing. This wing was controllable but had a higher sink rate and a faster forward speed than the normal wing.

- a. Redesign line and riser stowage. Lines and risers coming free and flailing around during the parachute mode caused entanglement which resulted in distortion of the wing or loss of control on many of the PDG drops in Thailand. This was the greatest single cause of failure. Lines and risers should not be free until required.

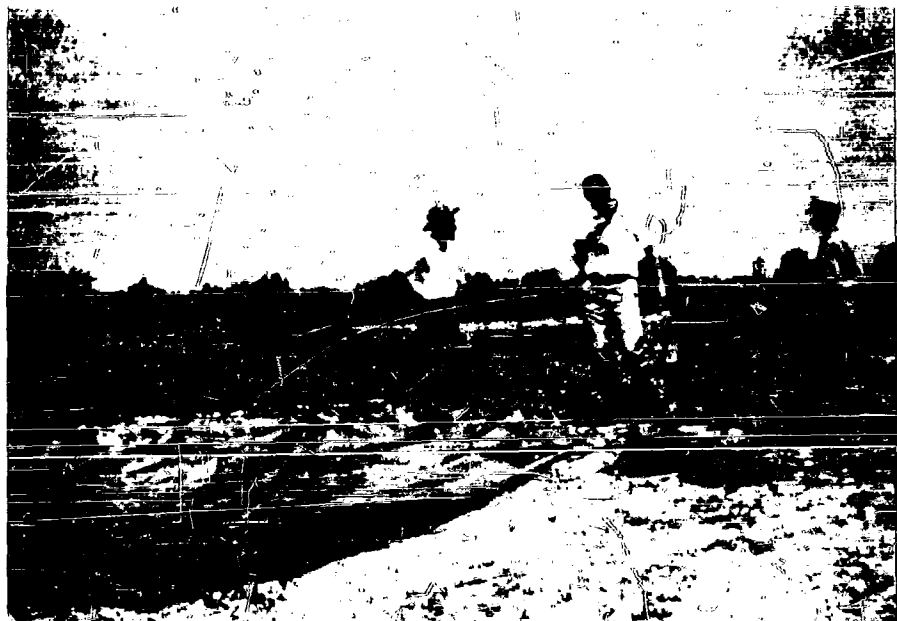
This photo shows the excellent condition of wing, control and cargo box after a normal flight.
